## Smoke and Dye-Water Observation Summary

### Western Run Pilot Project - Baltimore Maryland

STREET: FIELDCREST RD. 198 A3	MAP #1: 1	MH: 1521325
CITY: BALTIMORE	MAP #2:	MH: 1521757
LOCALE: SMALL RESIDENTIAL STREET	TAPE #: JAM 1	TV'D LGTH: 47.19 ft

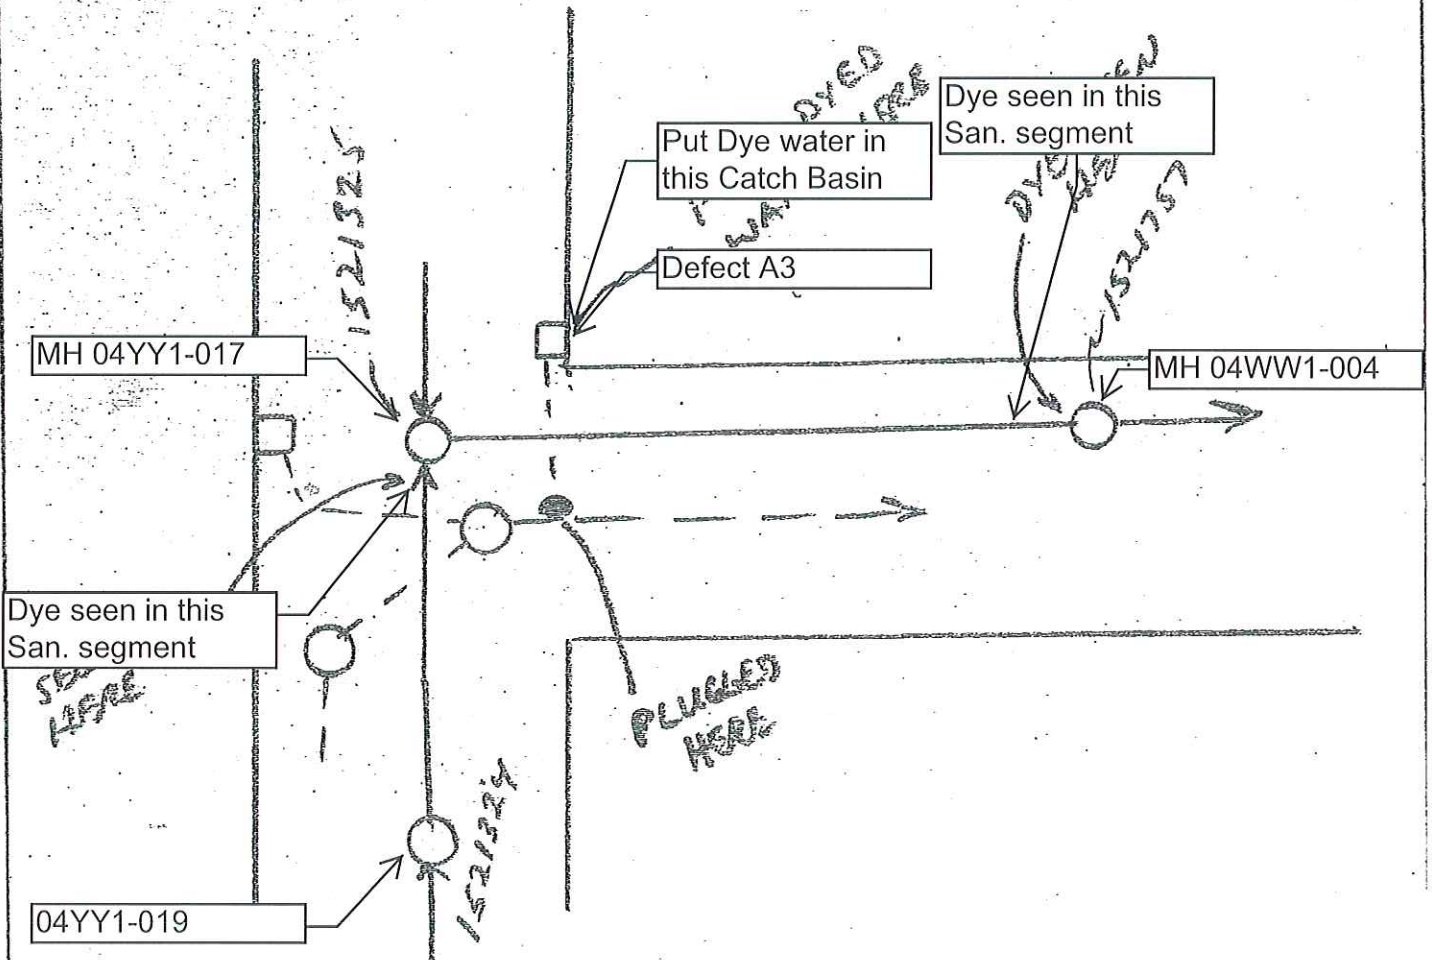
Sketch (NTS)  
Dye Test 198

SAW DYE IN TWO LINES

1521325 → 1521757 + 1521324 → 1521325

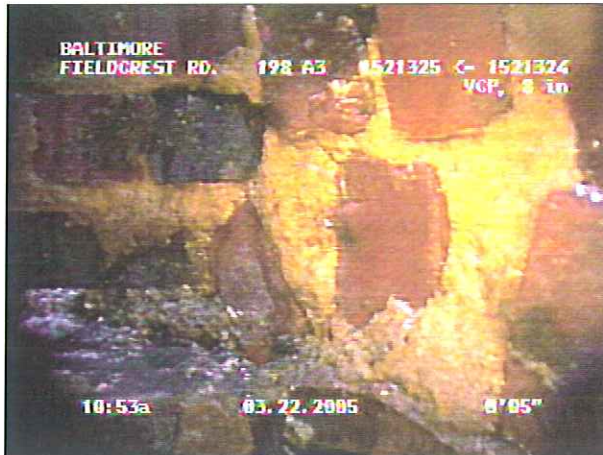
IMAGE: 81a, TAPE #: JAM 1, 01:17:03  
0.4FT, M.H. INFILTRATION

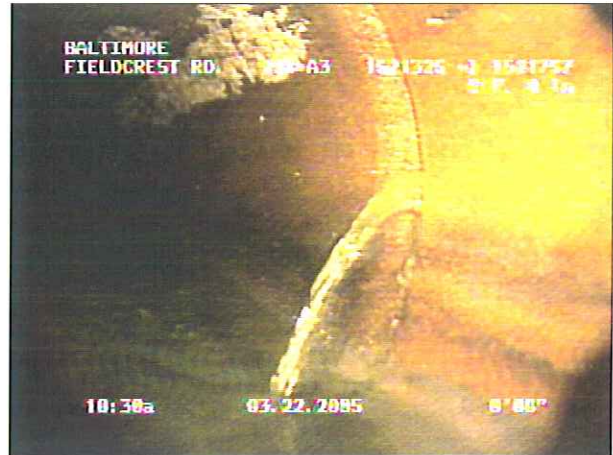
IMAGE: 68a, TAPE #: JAM 1, 01:08:17  
3FT, Infiltration Running at joint at 03 o'clock

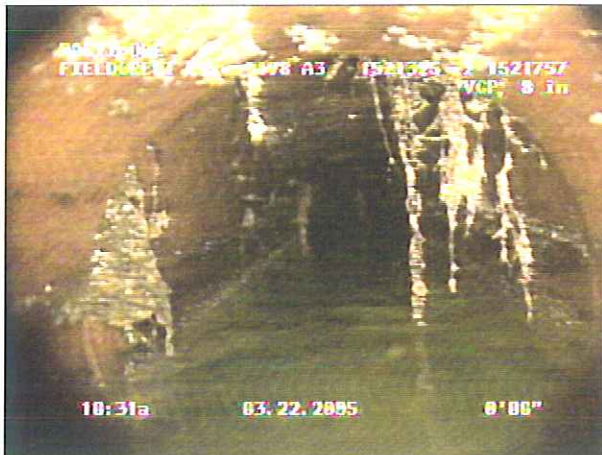
IMAGE: 69a, TAPE #: JAM 1, 01:09:04  
6FT, roots light, from 12 to 12 o'clock

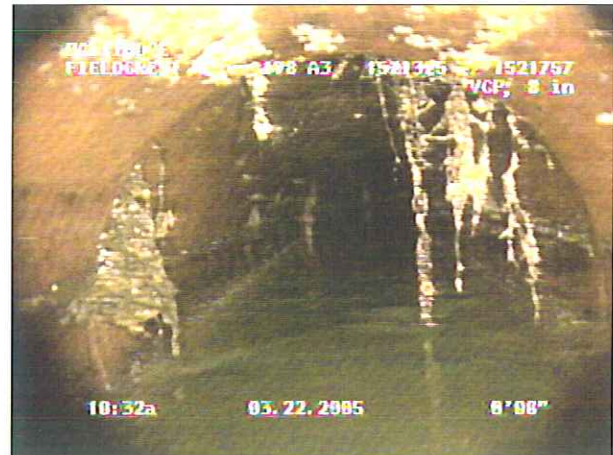
IMAGE: 70a, TAPE #: JAM 1, 01:09:04  
6FT, Infiltration Dripping at joint at 09 o'clock to 12 o'clock

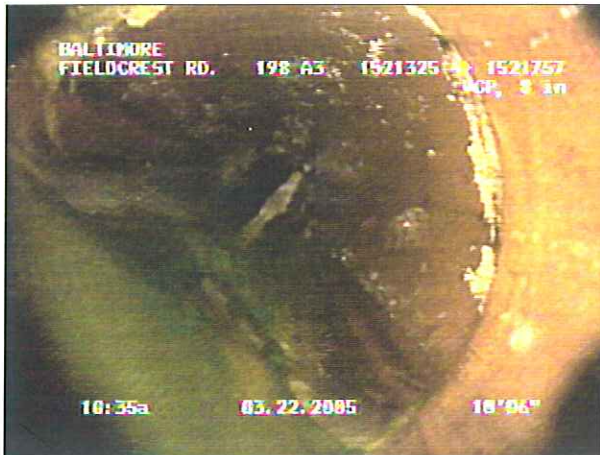
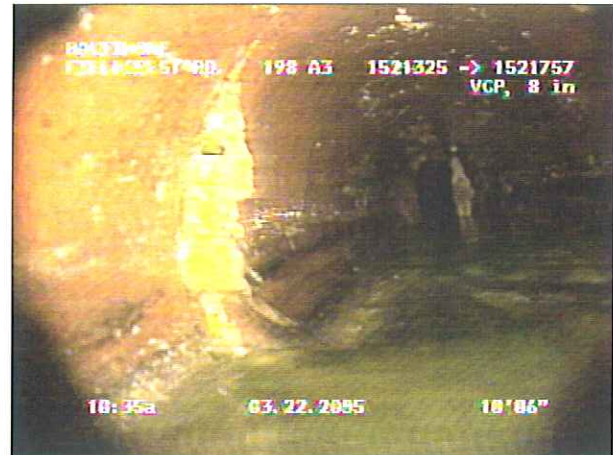
IMAGE: 71a, TAPE #: JAM 1, 01:09:48  
10.46FT, Infiltration Running at joint at 03 o'clock, 9 o'clock, and 12 o'clock

IMAGE: 71b, TAPE #: JAM 1, 01:09:48  
10.46FT, Infiltration Running at joint at 03 o'clock, 9 o'clock, and 12 o'clock

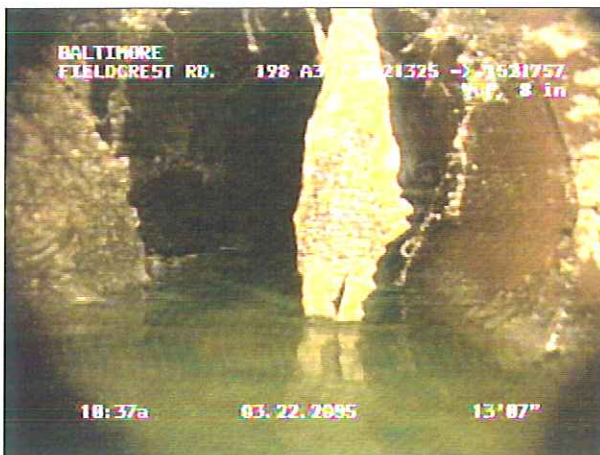
IMAGE: 72a, TAPE #: JAM 1, 01:10:27  
13.58FT, roots medium, from 12 to 12 o'clock

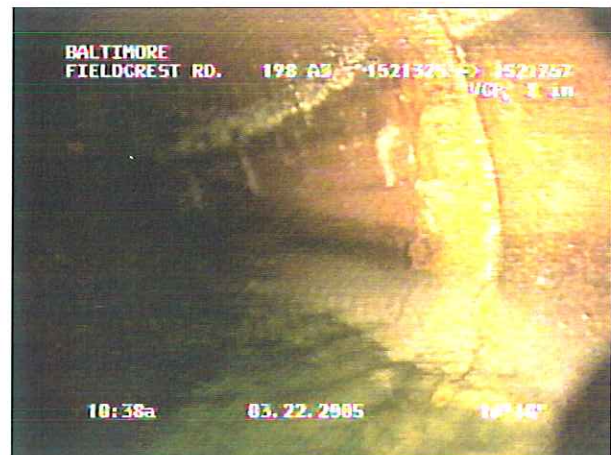
IMAGE: 73a, TAPE #: JAM 1, 01:11:27  
16.8FT, Infiltration Seeping at joint at 04 o'clock

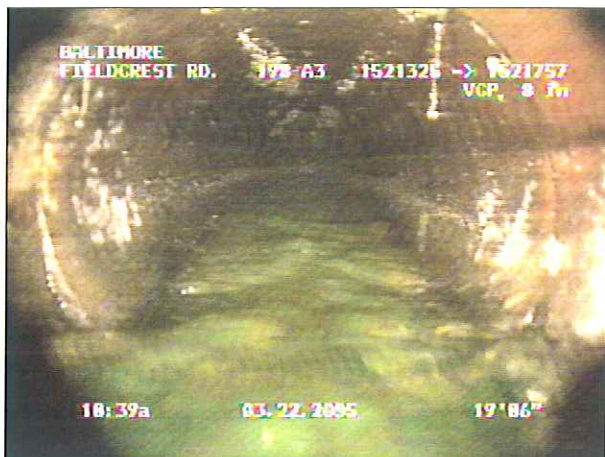
IMAGE: 74a, TAPE #: JAM 1, 01:12:01  
19.52FT, Infiltration Dripping at joint at 01 o'clock

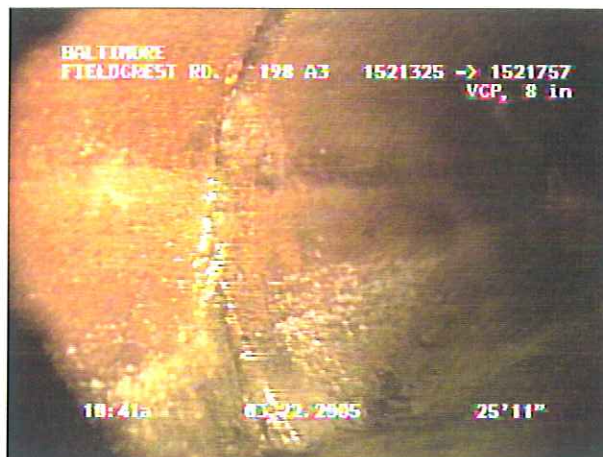
IMAGE: 75a, TAPE #: JAM 1, 01:12:57  
25.96FT, Infiltration Running at joint at 10 o'clock

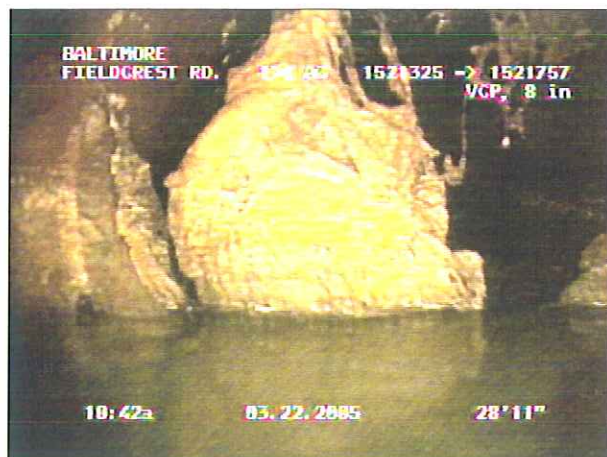
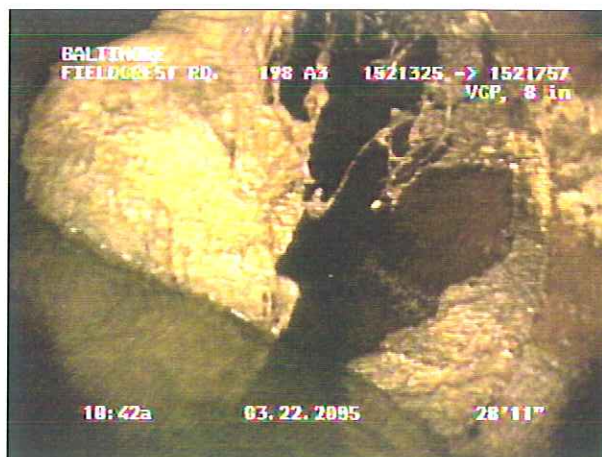
IMAGE: 76a, TAPE #: JAM 1, 01:13:40  
28.88FT, roots heavy, from 12 to 12 o'clock

IMAGE: 76b, TAPE #: JAM 1, 01:13:40  
28.88FT, roots heavy, from 12 to 12 o'clock

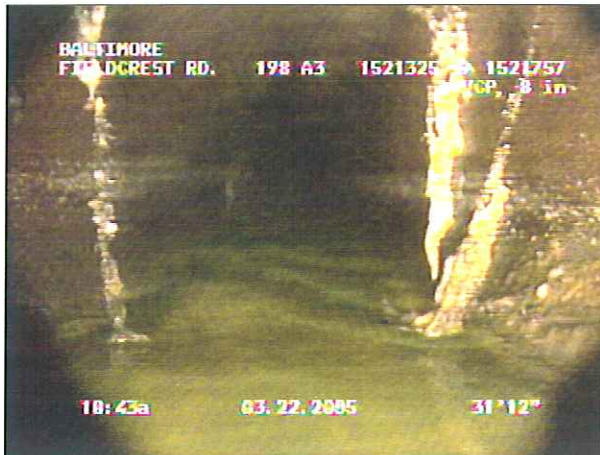
IMAGE: 77a, TAPE #: JAM 1, 01:14:24  
31.99FT, roots light, from 12 to 12 o'clock

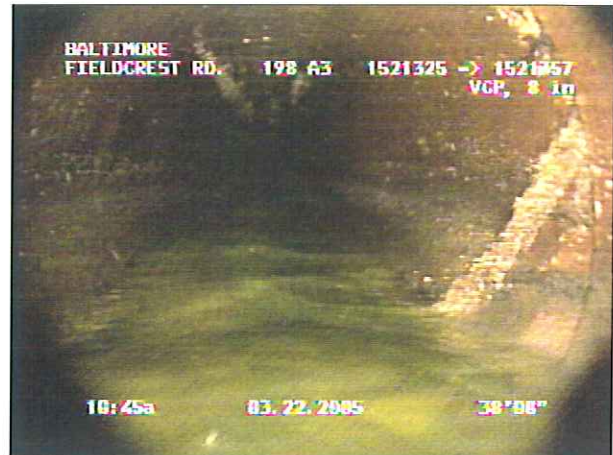
IMAGE: 78a, TAPE #: JAM 1, 01:15:21  
38.03FT, roots light, at 02 o'clock

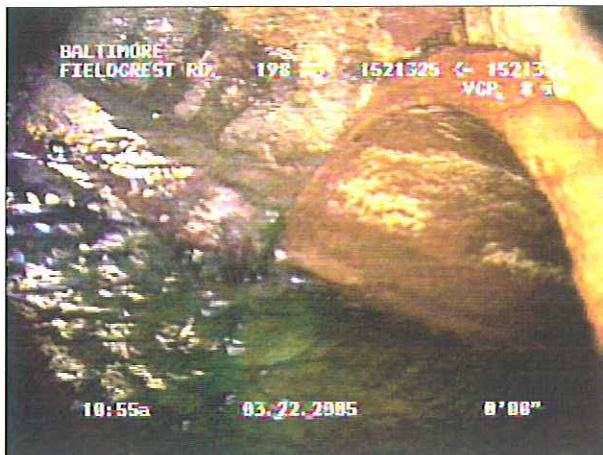
IMAGE: 82a, TAPE #: JAM 1, 01:17:52  
0.5FT, Infiltration Running at joint at 08 o'clock

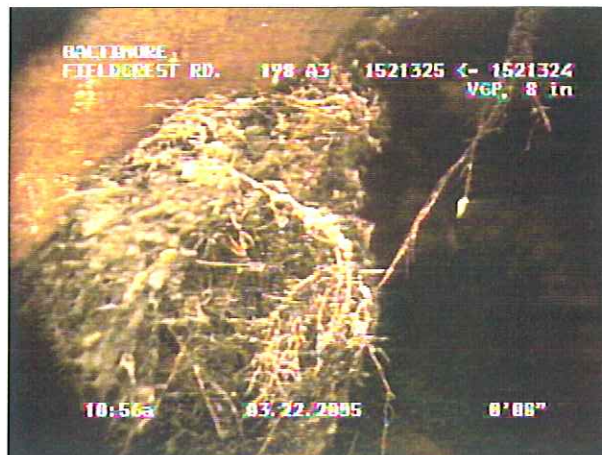
IMAGE: 83a, TAPE #: JAM 1, 01:18:11  
3FT, roots heavy, at 09 o'clock

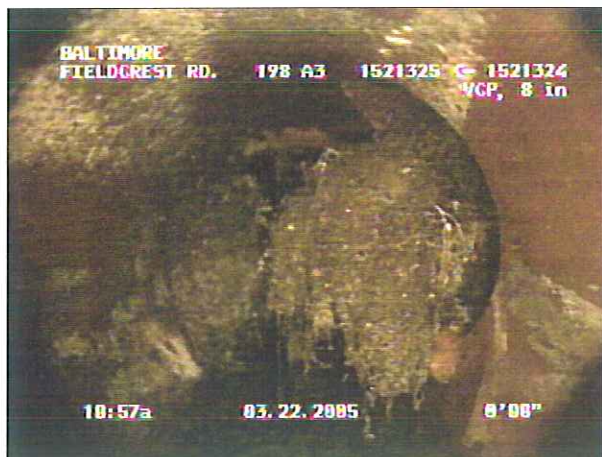
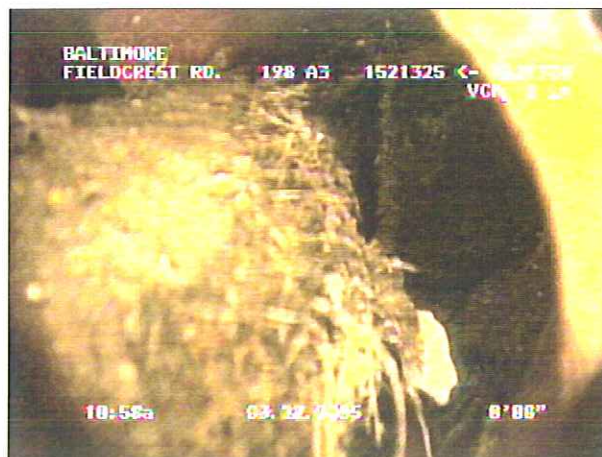
IMAGE: 84a, TAPE #: JAM 1, 01:18:50  
6FT, service connection with roots heavy at 02 o'clock

IMAGE: 84b, TAPE #: JAM 1, 01:18:50  
6FT, service connection with roots heavy at 02 o'clock

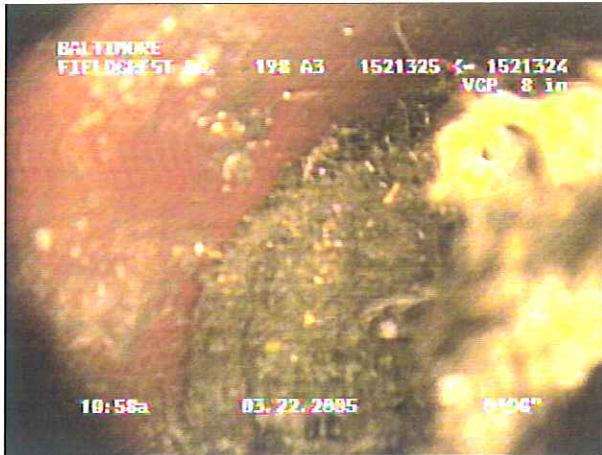
IMAGE: 85a, TAPE #: JAM 1, 01:19:31  
7FT, roots heavy, from 09 to 11 o'clock

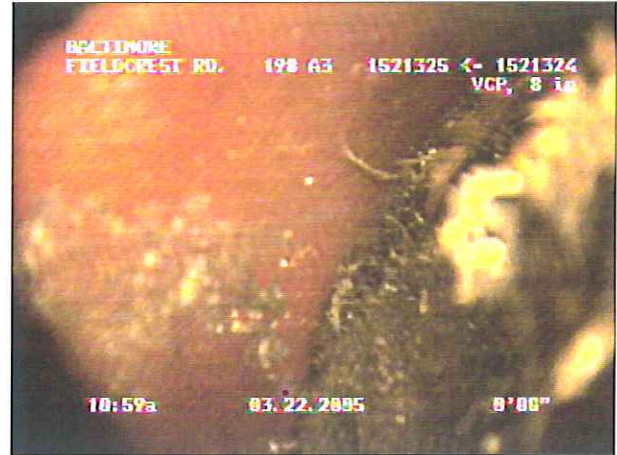
IMAGE: 86a, TAPE #: JAM 1, 01:19:31  
7FT, Infiltration Dripping at joint at 11 o'clock TO 12 o'clock

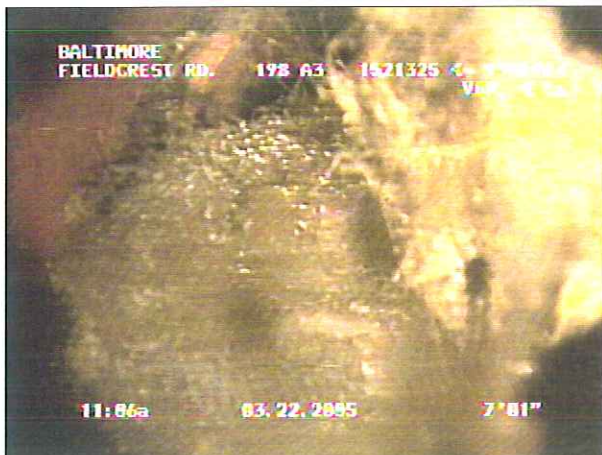
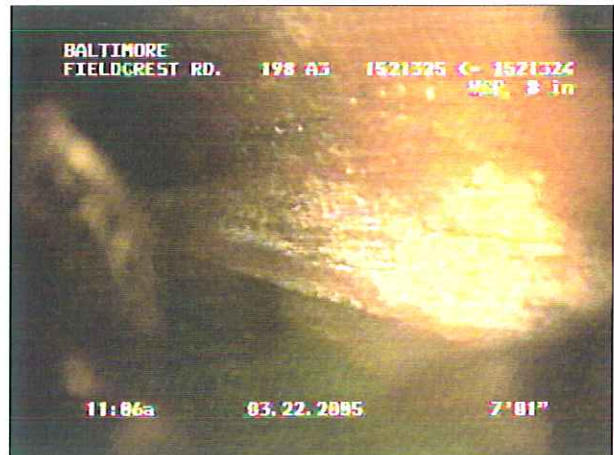
IMAGE: 87a, TAPE #: JAM 1, 01:22:04  
7.04FT, camera blocked, inspection abandoned, roots

IMAGE: 87b, TAPE #: JAM 1, 01:22:04  
7.04FT, camera blocked, inspection abandoned, roots

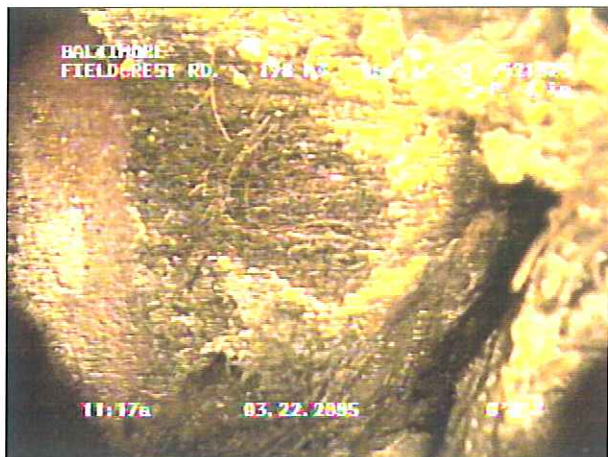
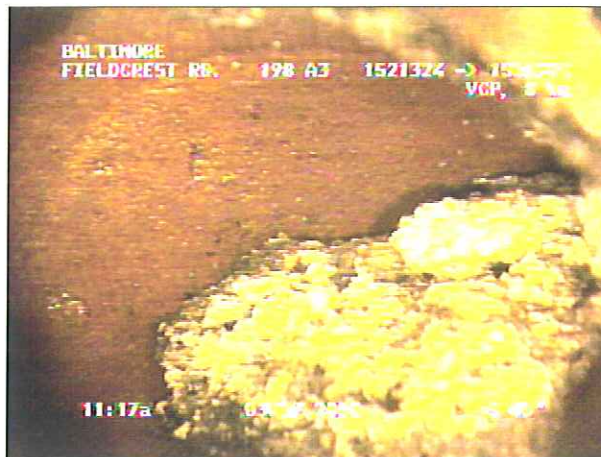
IMAGE: 88a, TAPE #: JAM 1, 01:23:14  
4FT, service connection with roots heavy at 03 o'clock

IMAGE: 88b, TAPE #: JAM 1, 01:23:14  
4FT, service connection with roots heavy at 03 o'clock

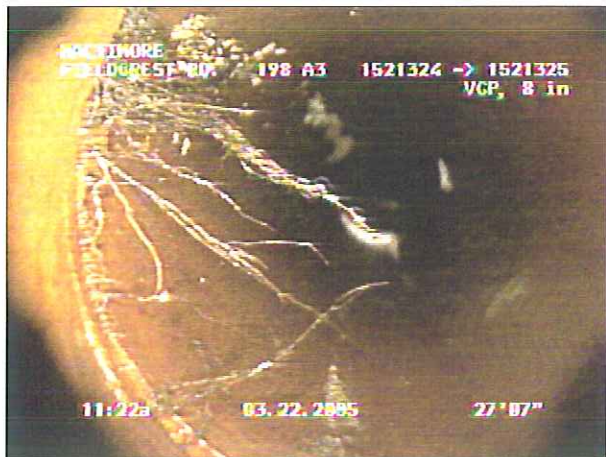
IMAGE: 90a, TAPE #: JAM 1, 01:25:41  
27.57FT, roots medium, START

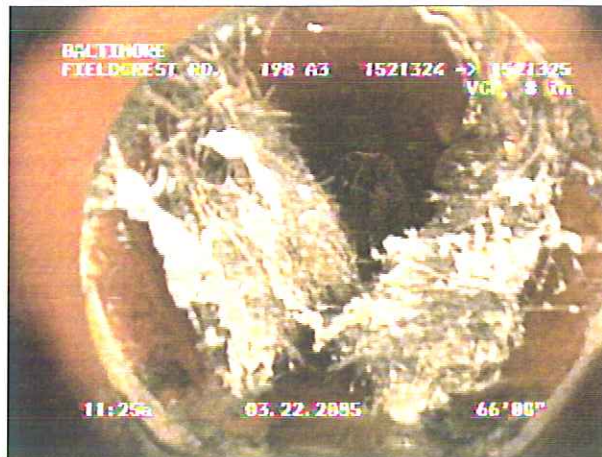
IMAGE: 93a, TAPE #: JAM 1, 01:27:59  
66FT, roots heavy, from 12 to 12 o'clock

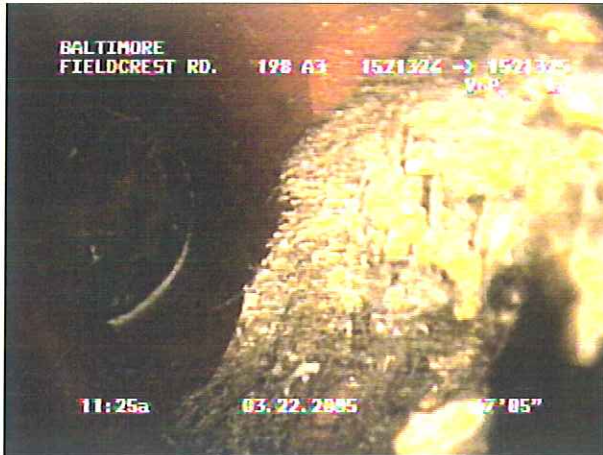
IMAGE: 94a, TAPE #: JAM 1, 01:28:21  
67.41FT, service connection with roots heavy at 03 o'clock

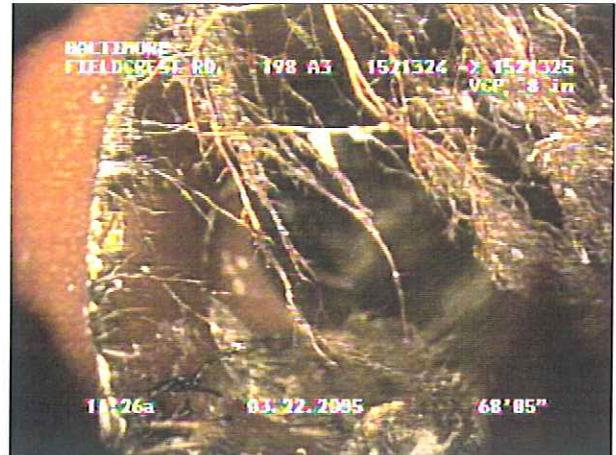
IMAGE: 95a, TAPE #: JAM 1, 01:28:47  
68.42FT, roots heavy, from 12 to 12 o'clock

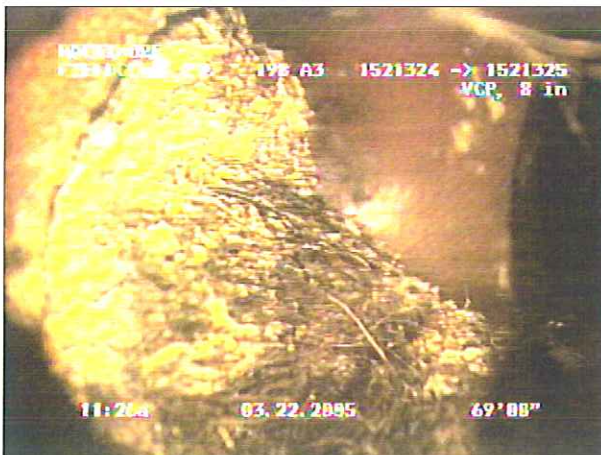
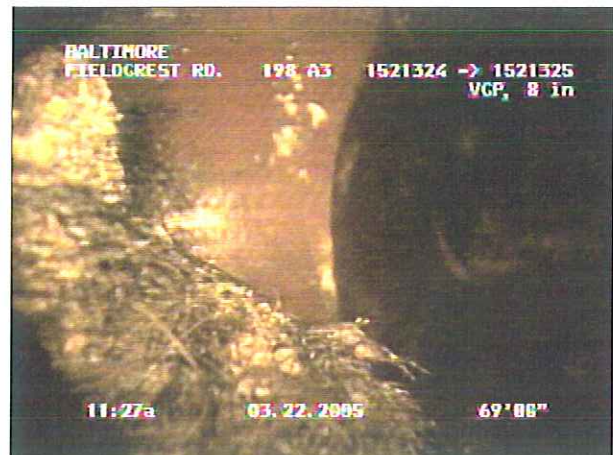
IMAGE: 96a, TAPE #: JAM 1, 01:29:09  
69.02FT, service connection with roots heavy at 09 o'clock

IMAGE: 96b, TAPE #: JAM 1, 01:29:09  
69.02FT, service connection with roots heavy at 09 o'clock

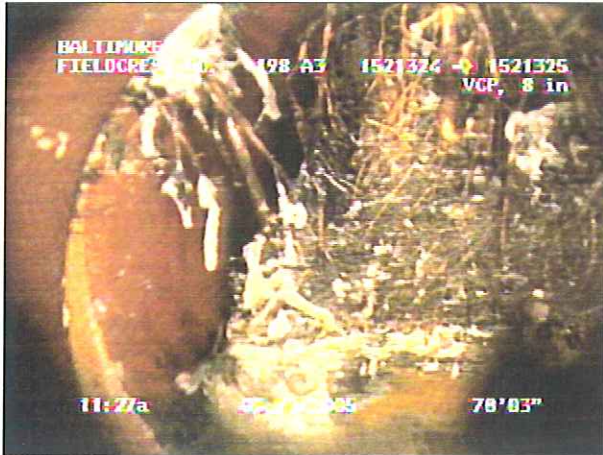
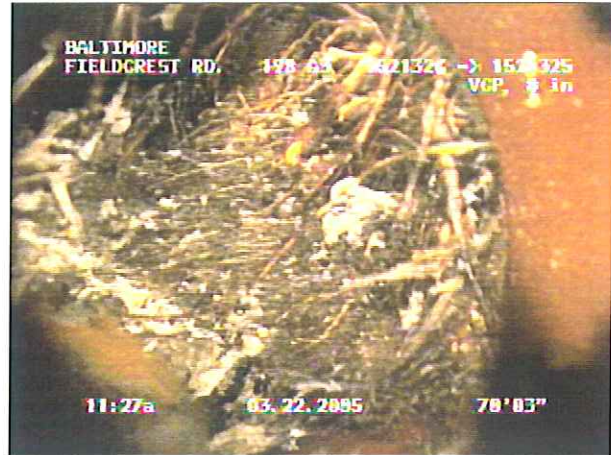
IMAGE: 97a, TAPE #: JAM 1, 01:29:36  
70.23FT, roots heavy, from 12 to 12 o'clock

IMAGE: 97b, TAPE #: JAM 1, 01:29:36  
70.23FT, roots heavy, from 12 to 12 o'clock

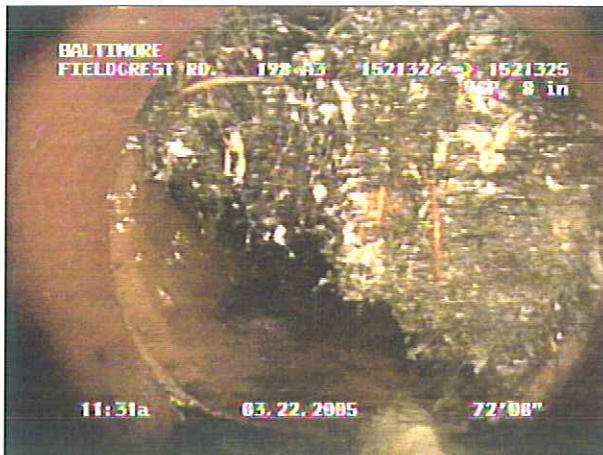
IMAGE: 98a, TAPE #: JAM 1, 01:30:57  
72.04FT, roots heavy, from 12 to 12 o'clock

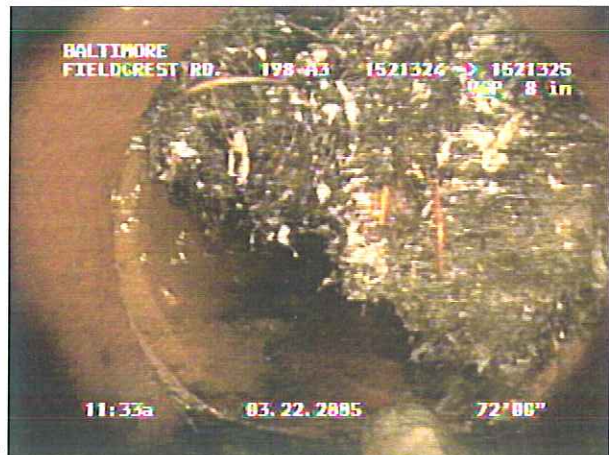
IMAGE: 91a, TAPE #: JAM 1, 01:30:57  
73FT, camera blocked, inspection abandoned, TOO MANY ROOTS
